**Flood Control Project Maintenance  
Levee Inspections****LMA District Cover Sheet****Spring 2012 Levee Inspection Results****Marysville Levee Commission**

**Levee Inspection Report By Mile - Spring 2012**

| Waterway | Bank | Unit Miles | Inspection Start/End | Inspector |
|---|---|---|---|---|
| Unit No. 01 Simmerly Slough | Left | 3.25 | 04/03/2012<br>04/03/2012 | Clay Thomas |

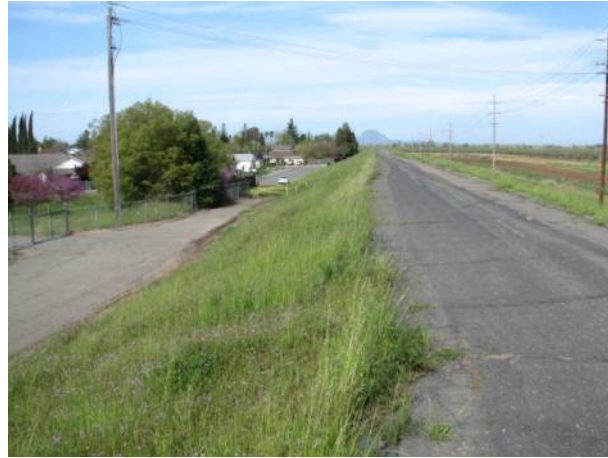
dpesaven\_s\_20120504\_037.JPG

This photo shows the landside vegetation looking upstream from levee mile 3.20.

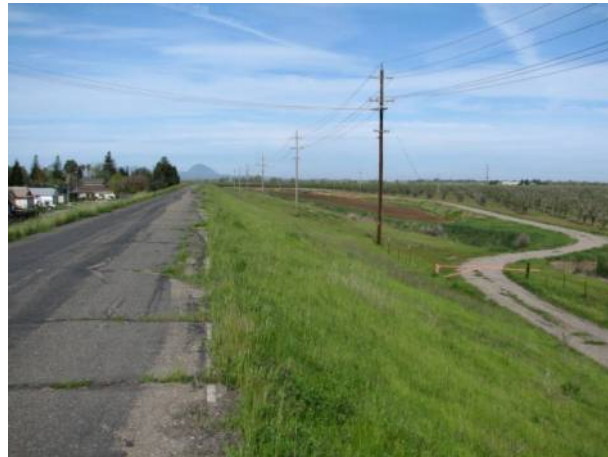
dpesaven\_s\_20120504\_036.JPG

This photo shows the waterside vegetation looking upstream from levee mile 3.20.

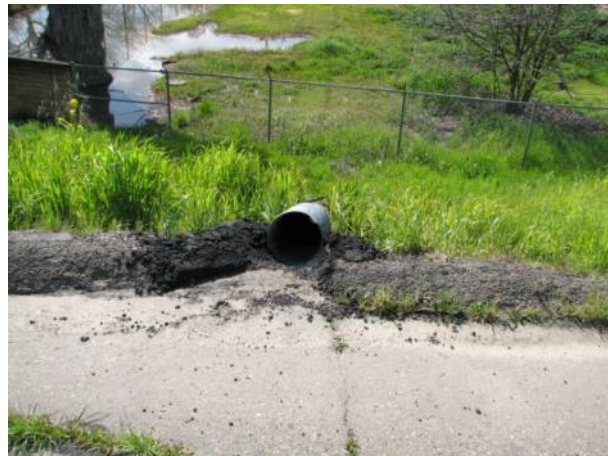
cathom\_s\_20120307\_032.jpg

This site is on the Corps PI.

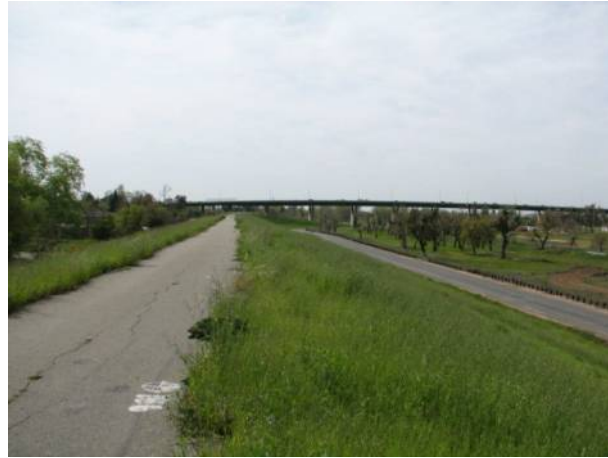
dpesaven\_s\_20120504\_001.JPG

| LMR No. | Levee Mile | | Category | Item | Location * | Rating ** | Action/Comment | GPS Latitude/Longitude | | Issue No. |
|---|---|---|---|---|---|---|--|---|---|---|
| 1 | 0.02 | 1.24 | Earthen Levee | Vegetation | WS | M<br>Ma | V1 : Control annual grass and weeds on the levee slopes and easements. | 39.149392 °<br>-121.601099 ° | 39.134892 °<br>-121.594253 ° | 3<br>Y |

View of waterward slope looking downstream.

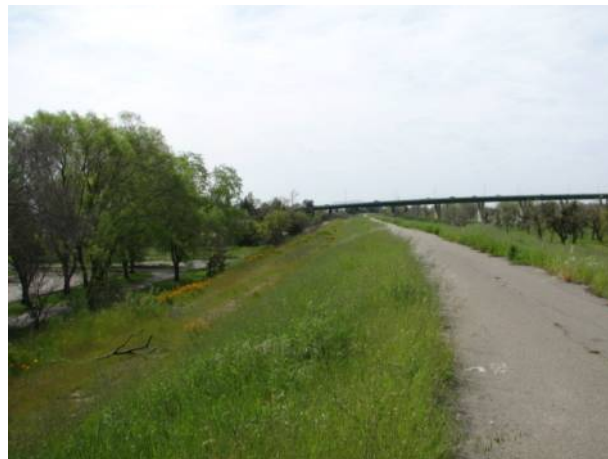
dpesaven\_s\_20120504\_002.JPG

| LMR No. | Levee Mile | | Category | Item | Location * | Rating ** | Action/Comment | GPS Latitude/Longitude | | Issue No. |
|---|---|---|---|---|---|---|--|---|---|---|
| 2 | 0.02 | 1.24 | Earthen Levee | Vegetation | LS | M<br>Ma | V1 : Control annual grass and weeds on the levee slopes and easements. | 39.149391 °<br>-121.601099 ° | 39.134892 °<br>-121.594252 ° | 2<br>Y |

View of landward slope looking downstream.

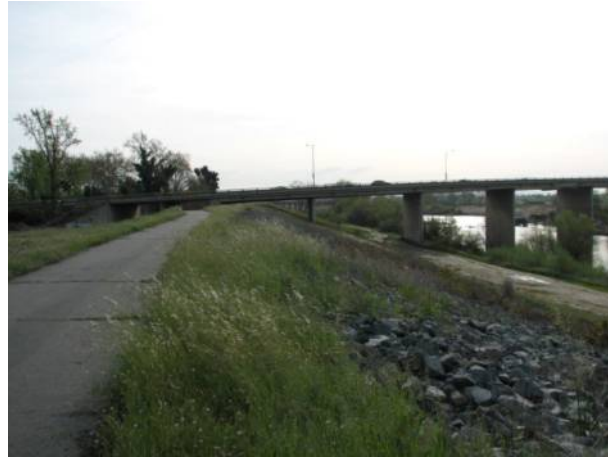
dpesaven\_s\_20120504\_040.JPG

| LMR No. | Levee Mile | | Category | Item | Location<br>* | Rating<br>** | Action/Comment | GPS Latitude/Longitude | | Issue No.<br>Photo |
|---|---|---|---|---|---|---|--|---|---|---|
| 1 | 0.13 | 1.60 | Earthen Levee | Vegetation | WS | M<br>Ma | V1 : Control annual grass and weeds on the levee slopes and easements. | 39.135163 °<br>-121.591602 ° | 39.148569 °<br>-121.577876 ° | 5<br>Y |

View of the waterward slope looking upstream.

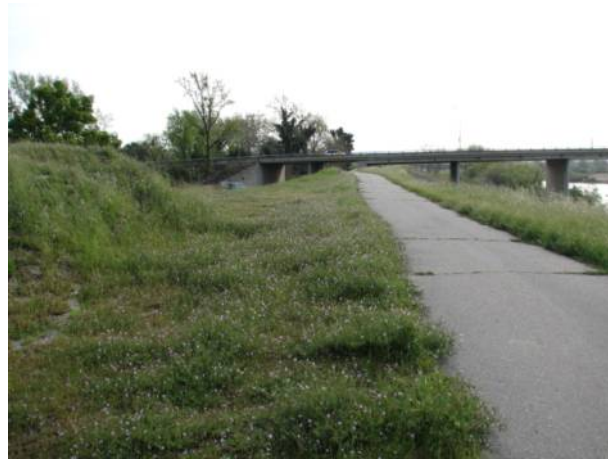
dpesaven\_s\_20120504\_039.JPG

| LMR No. | Levee Mile | | Category | Item | Location<br>* | Rating<br>** | Action/Comment | GPS Latitude/Longitude | | Issue No.<br>Photo |
|---|---|---|---|---|---|---|--|---|---|---|
| 2 | 0.13 | 1.60 | Earthen Levee | Vegetation | LS | M<br>Ma | V1 : Control annual grass and weeds on the levee slopes and easements. | 39.135163 °<br>-121.591602 ° | 39.148569 °<br>-121.577876 ° | 2<br>Y |

View of the landward slope looking upstream.

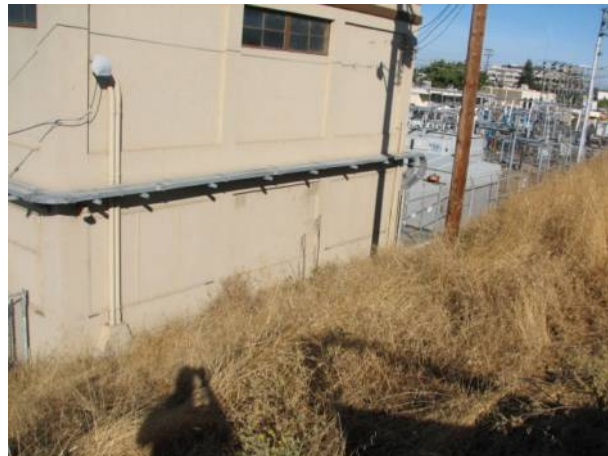
cathom\_s\_20120307\_036.jpg

| LMR No. | Levee Mile | | Category | Item | Location<br>* | Rating<br>** | Action/Comment | GPS Latitude/Longitude | | Issue No.<br>Photo |
|---|---|---|---|---|---|---|--|---|---|---|
| 4 | 0.86 | 0.86 | Earthen Levee | Encroachments | LS | U<br>En | BU : Buildings | 39.139843 °<br>-121.583033 ° | 39.139843 °<br>-121.583033 ° | 4<br>Y |

Building encroaching at land side levee toe.

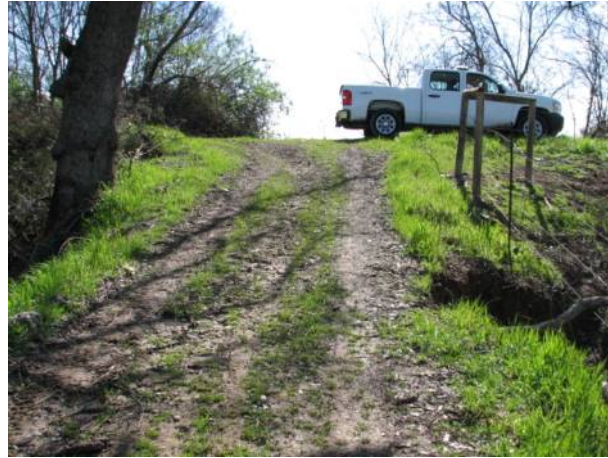
cathom\_s\_20120307\_038.jpg

| LMR No. | Levee Mile | | Category | Item | Location<br>* | Rating<br>** | Action/Comment | GPS Latitude/Longitude | | Issue No.<br>Photo |
|---|---|---|---|---|---|---|--|---|---|---|
| 6 | 5.54 | 5.54 | Earthen Levee | Encroachments | CR | M<br>En | RA : Ramp<br>Inspector Comments: This is on the patrol road. | 39.190993 °<br>-121.530650 ° | 39.190993 °<br>-121.530650 ° | 10<br>Y |

This ramp is on the patrol road, no known permit.
